**Experimental Investigation on the Influence of Surface Defects on
High-Speed Gear Performance**

Undergraduate Honors Thesis

The Ohio State University

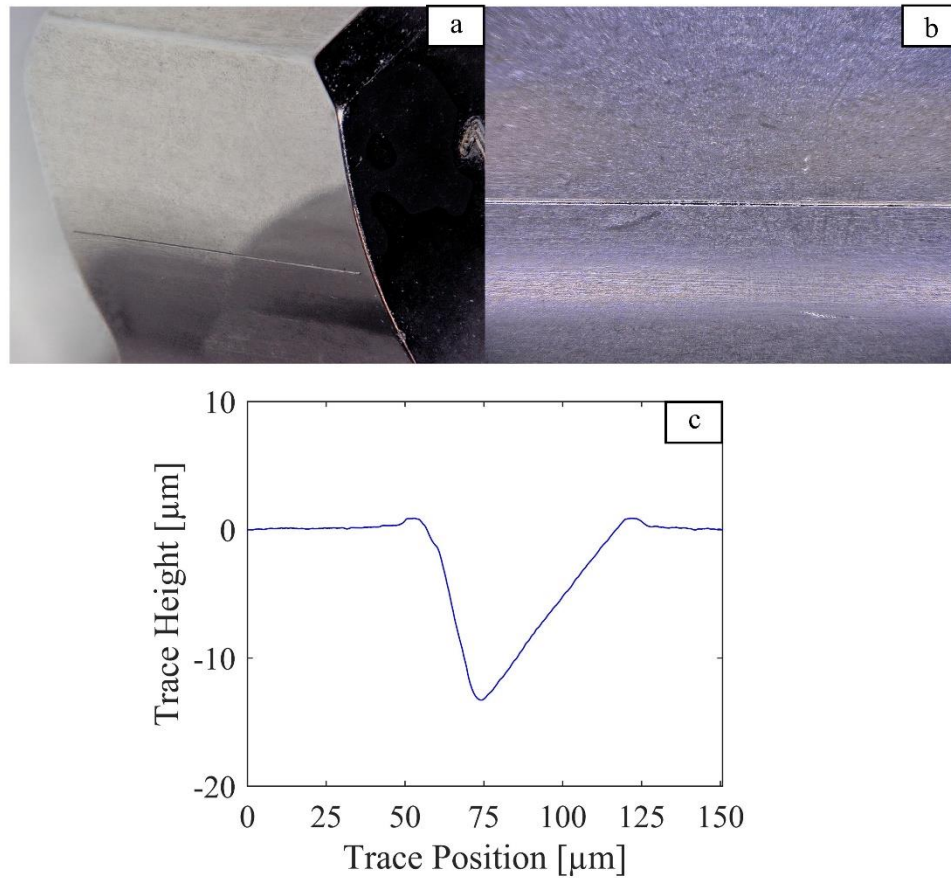
Figure 2.7: (a) Macroscopic image, (b) microscopic image, and (c) roughness trace of the LPSTC scratch tested in this study.

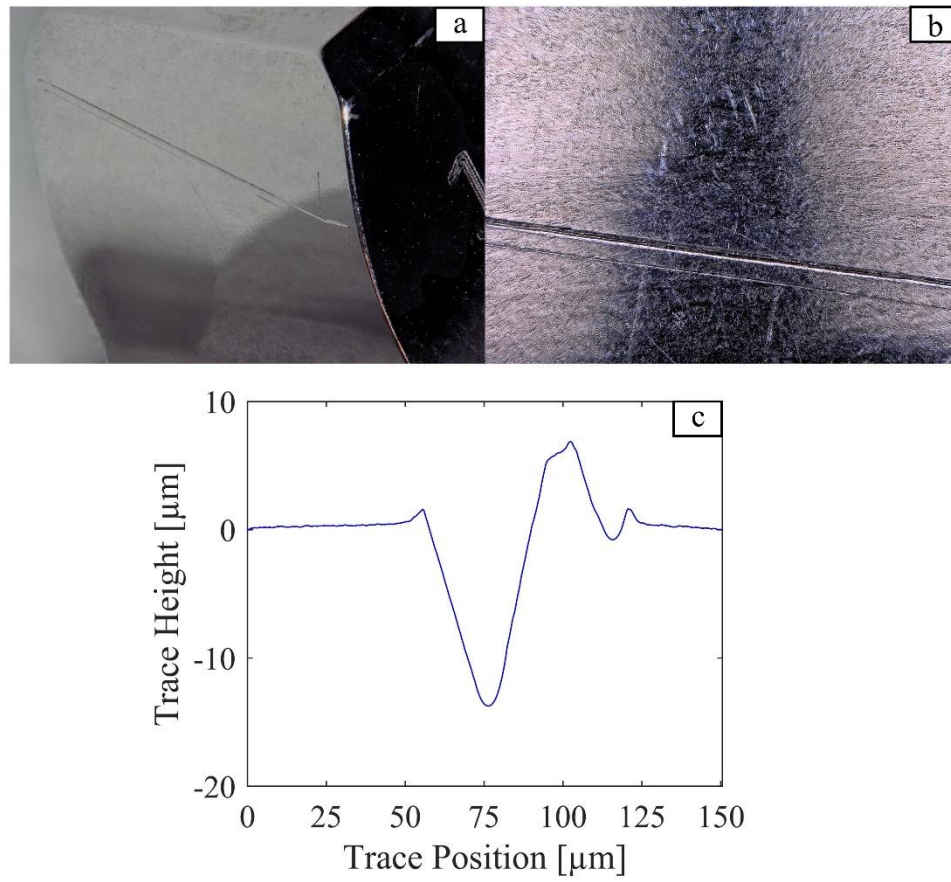
Figure 2.8: (a) Macroscopic image, (b) microscopic image, and (c) roughness trace of the diagonal scratch tested in this study.

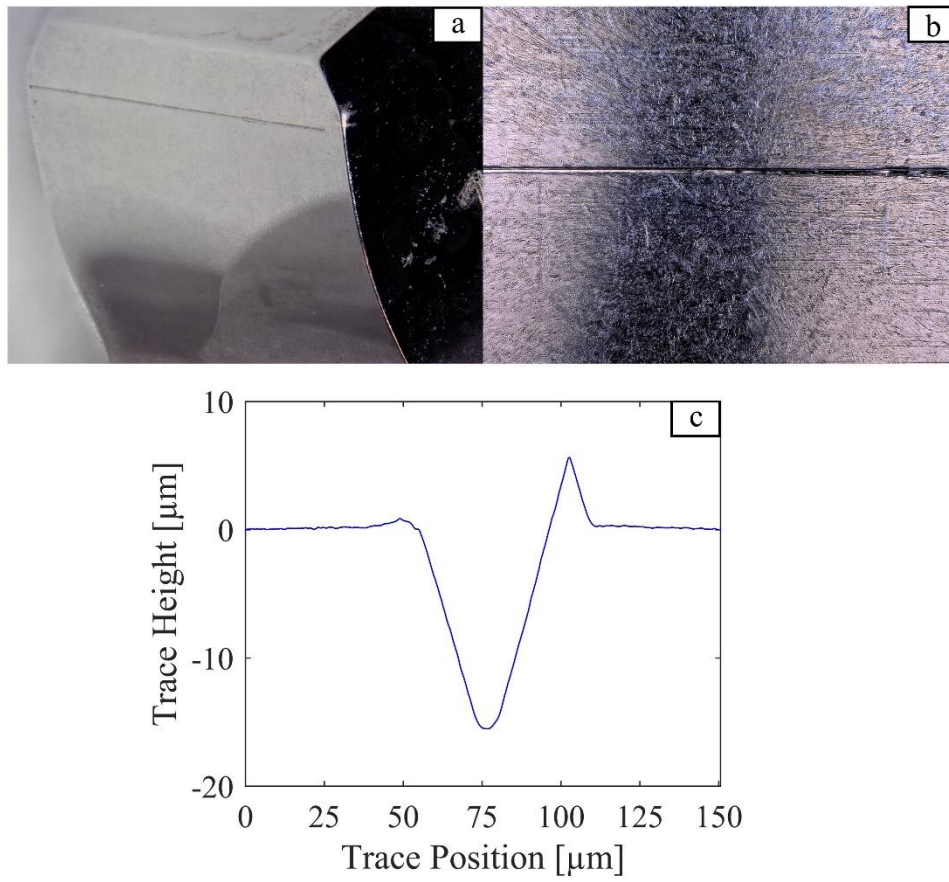
Figure 2.9: (a) Macroscopic image, (b) microscopic image, and (c) roughness trace of the HPSTC scratch tested in this study.

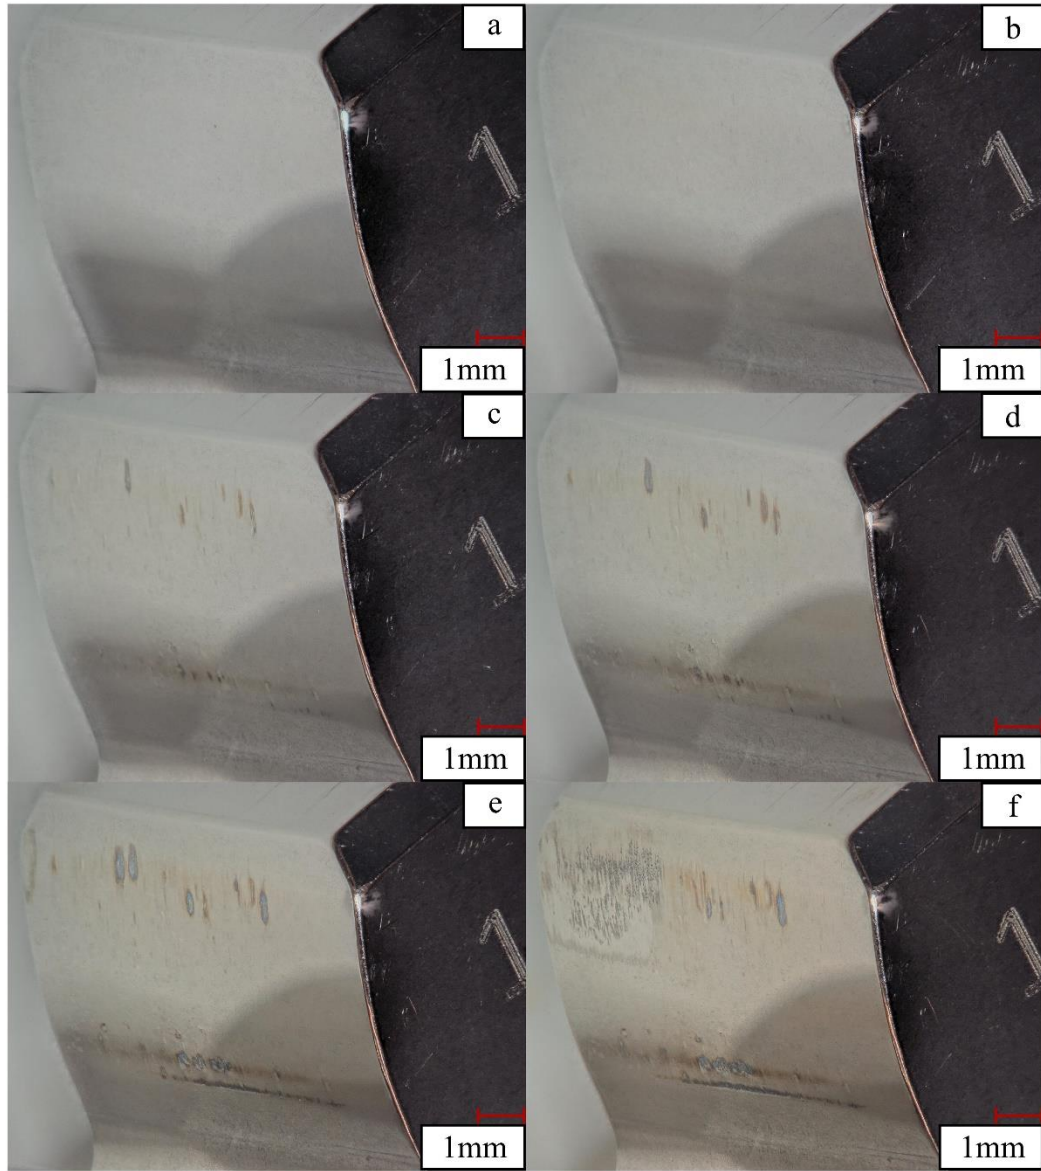
Figure 3.1 shows the pinion reference tooth from the undamaged tests after scuffing stages A1, A2, A3, A9, B9 and C9. Various areas of discoloration and apparent damage are seen to accumulate with each scuffing stage. While most of these were superficial, one gouge was observed in the left addendum of the pinion after stage A3 (Figure 3.1(c)). This gouge progressed slowly before causing a sizable scuffing zone in the same area during stage C9 as shown in Figure 3.1(f). Stage C9 was halted prematurely due to a sharp increase in vibrations caused by scuffing. Table 3.1 lists the operating conditions of stage C9 as the failure stage for this test.

Figure 3.1: Macro-images of the pinion tooth having no scratch in site 4 (a) before the test, and after the stages of (b) A1 (c) A3, (d) A9, (e) B9, and (f) C9.

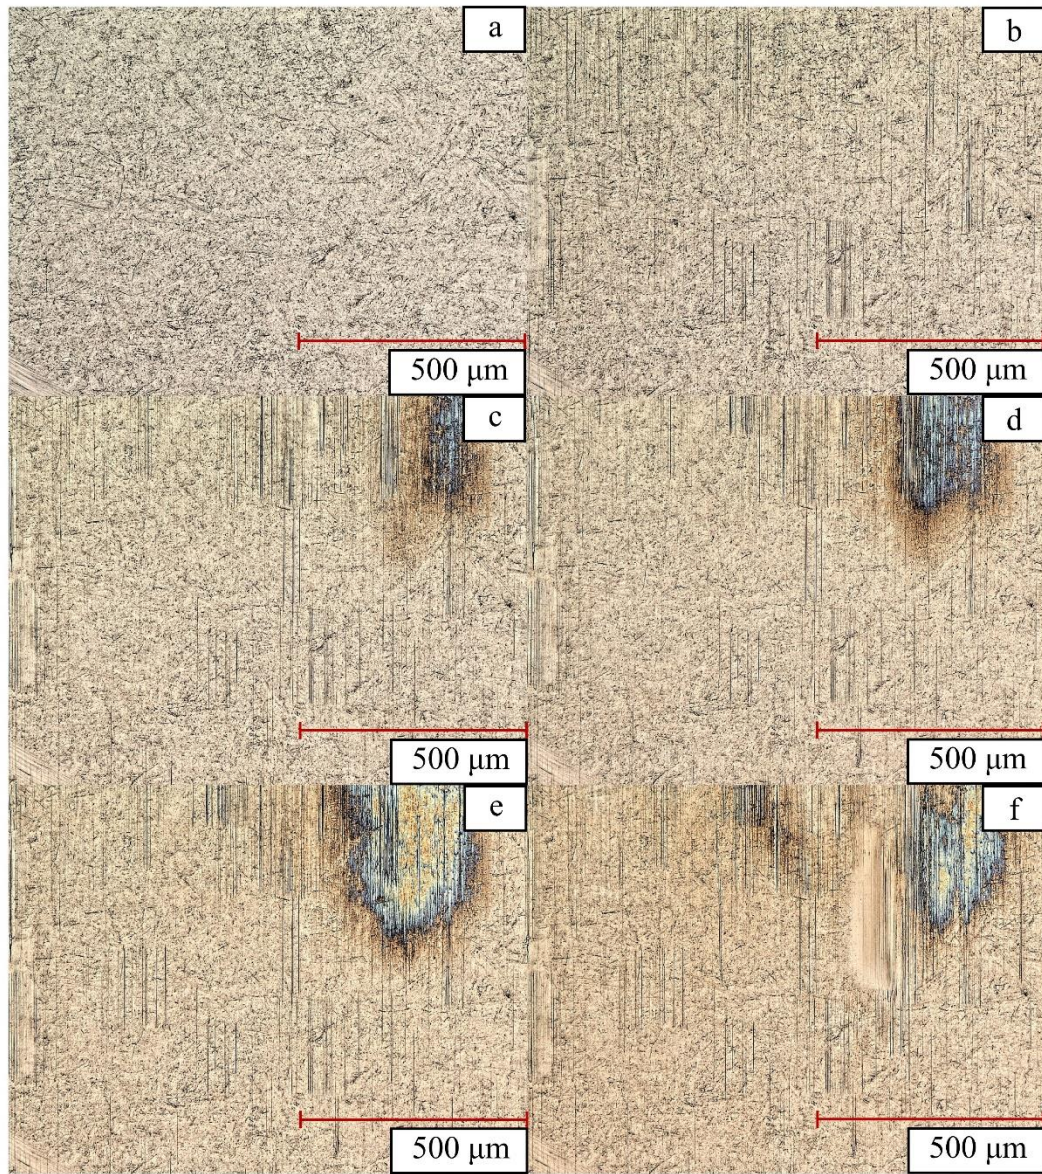
Figure 3.2: 300X images of the pinion tooth having no scratch in HPSTC areas of site 4 (a) before the test, and after the stages of (b) A1 (c) A3, (d) A9, (e) B9, and (f) C9.

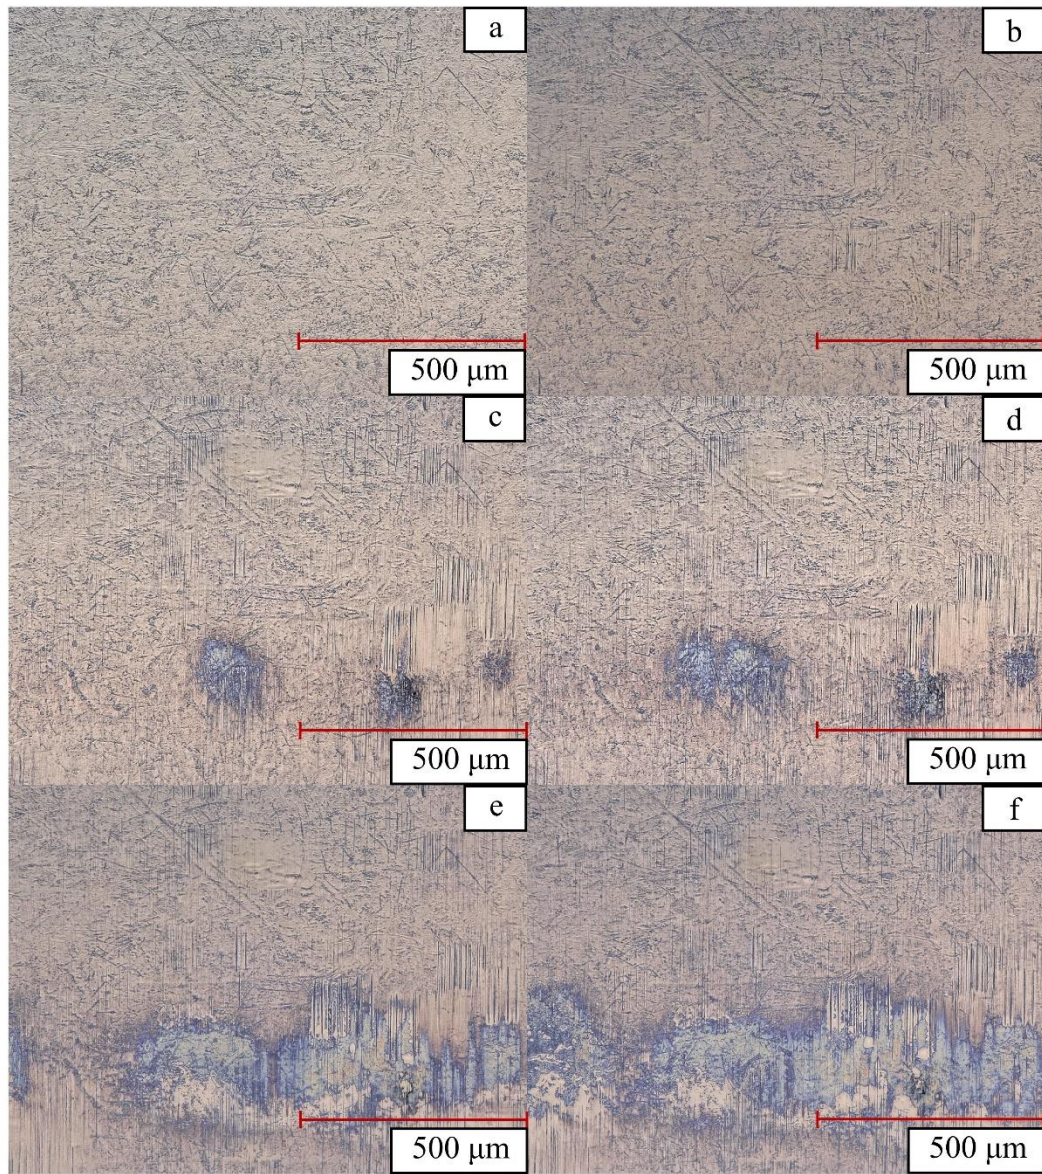
Figure 3.3: 300X images of the pinion tooth having no scratch in LPSTC areas of site 4 (a) before the test, and after the stages of (b) A1 (c) A3, (d) A9, (e) B9, and (f) C9.

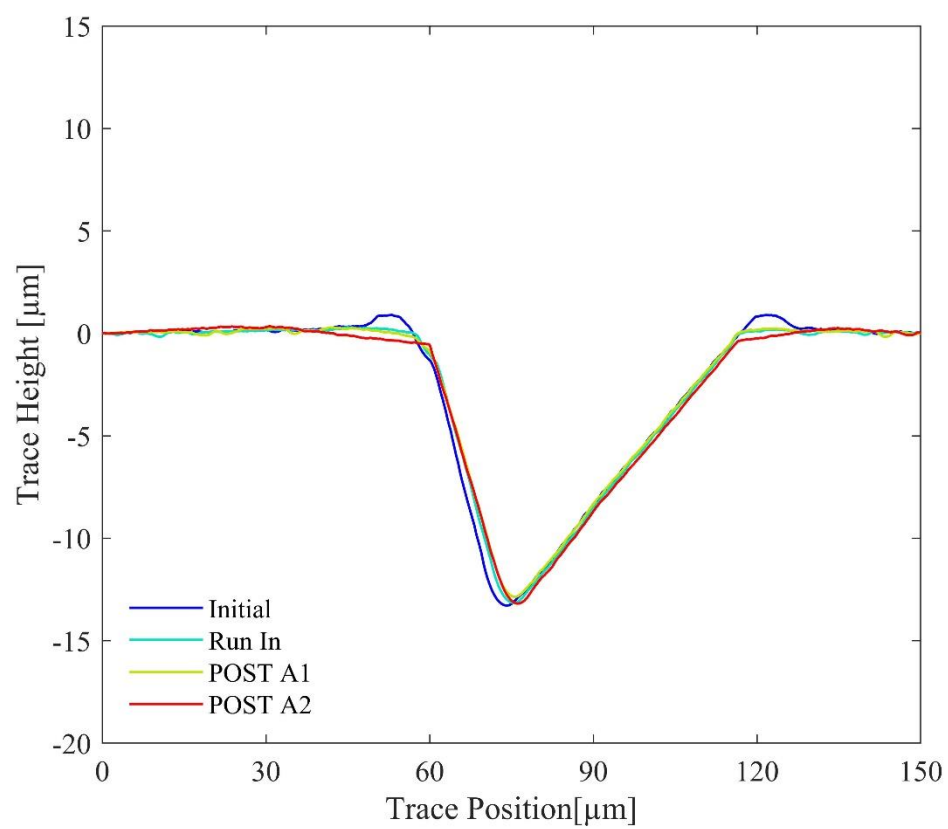
The first damaged gear pair to be run used a pinion scratched along its LPSTC line. This gear pair was first run through three run-in stages. It subsequently survived the first two scuffing stages before scuffing at stage A3, as listed in Table 3.1. Figure 3.4 shows roughness traces across this scratch at section 4 (middle of the tooth) in its pre-test form as well as after run-in and staged tests. Focusing on the pre-test scratch profile (blue line), the dimensional parameters of this scratch as defined in Figure 2.6 were $H = 15 \text{ } \mu\text{m}$, $\alpha = 0.11$, $\beta = 4.44$, and $\gamma = 0.60$. The small α value indicates that the plus material initially present along the edges of the scratch was minimal. Traces performed after run-in and staged tests do not exhibit any plus material as they wore out during the run in. Otherwise, the overall shape of the scratch remained relatively unchanged during the tests.

Figure 3.4: Roughness profiles of the LPSTC scratch at site 4.

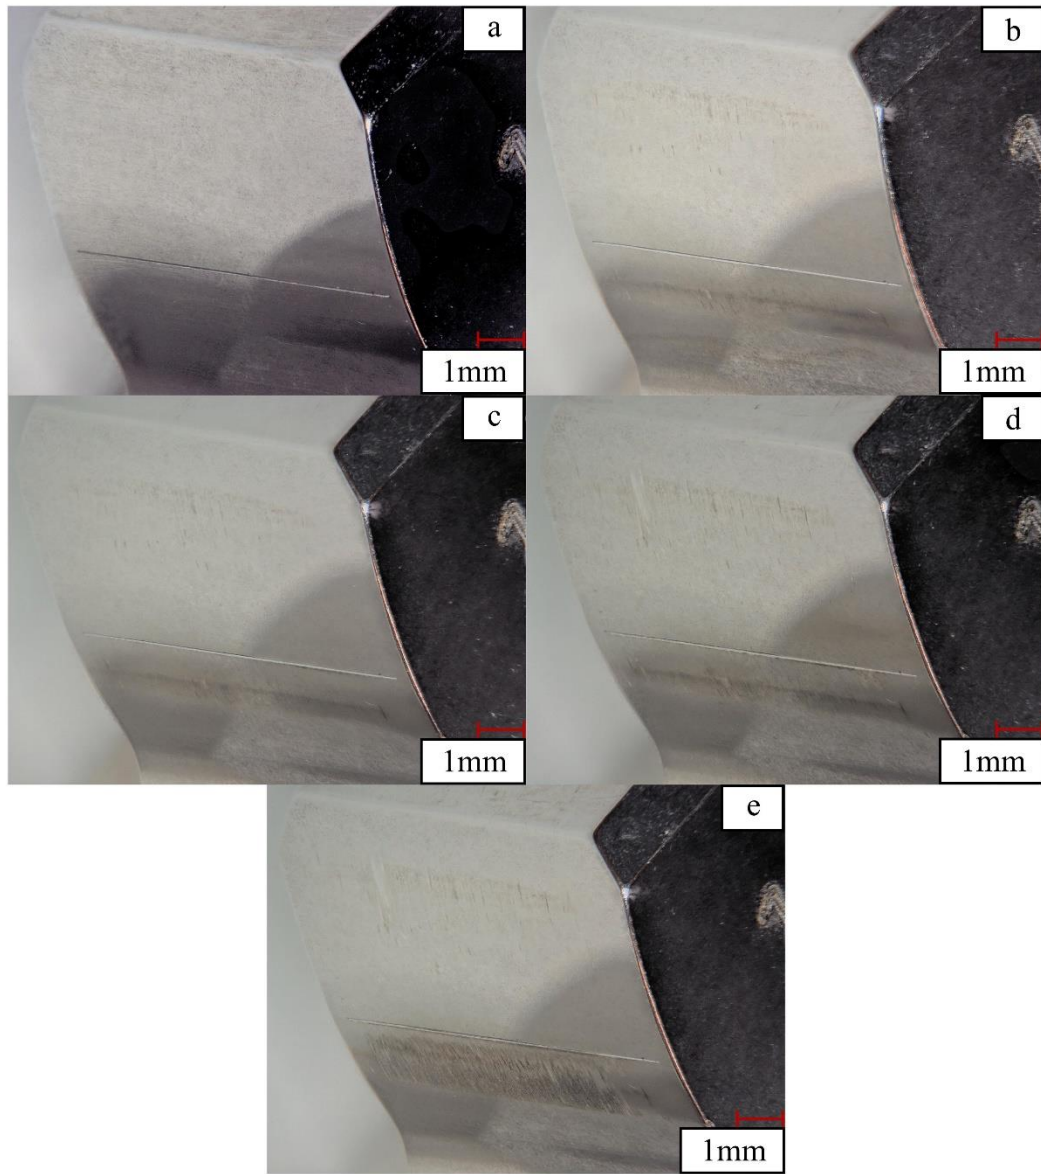
Figure 3.5 shows the entire pinion tooth having the LPSTC scratch at pre-test and after run-in and scuffing test stages. While the tooth surface is seen to maintain its integrity all the way to the end of stage A2 (Fig. 3.5(d)), a band of scuffing marks covering the entire face width along the dedendum is evident in Figure 3.5(e). 100X close-up views of the scratched area within section 4 are shown in Figure 3.6. Very little or no changes are observed along the scratch after various test stages. Furthermore, the scuffing region in Figure 3.6(e) after stage A3 is clearly below the scratch with no conclusive evidence that the scratch might have induced the scuffing failure.

Figure 3.5: Macro-images of the pinion tooth having the LPSTC scratch in site 4 (a) before the test, and after the stages of (b) run-in, (c) A1, (d) A2, and (e) A3.

Although the scuffing failure region shown in Figures 3.5(e) and 3.6(e) was clearly separated from the scratch, it can still be hypothesized that the failure is still caused by the scratch indirectly through additional heat and loose debris caused by it.

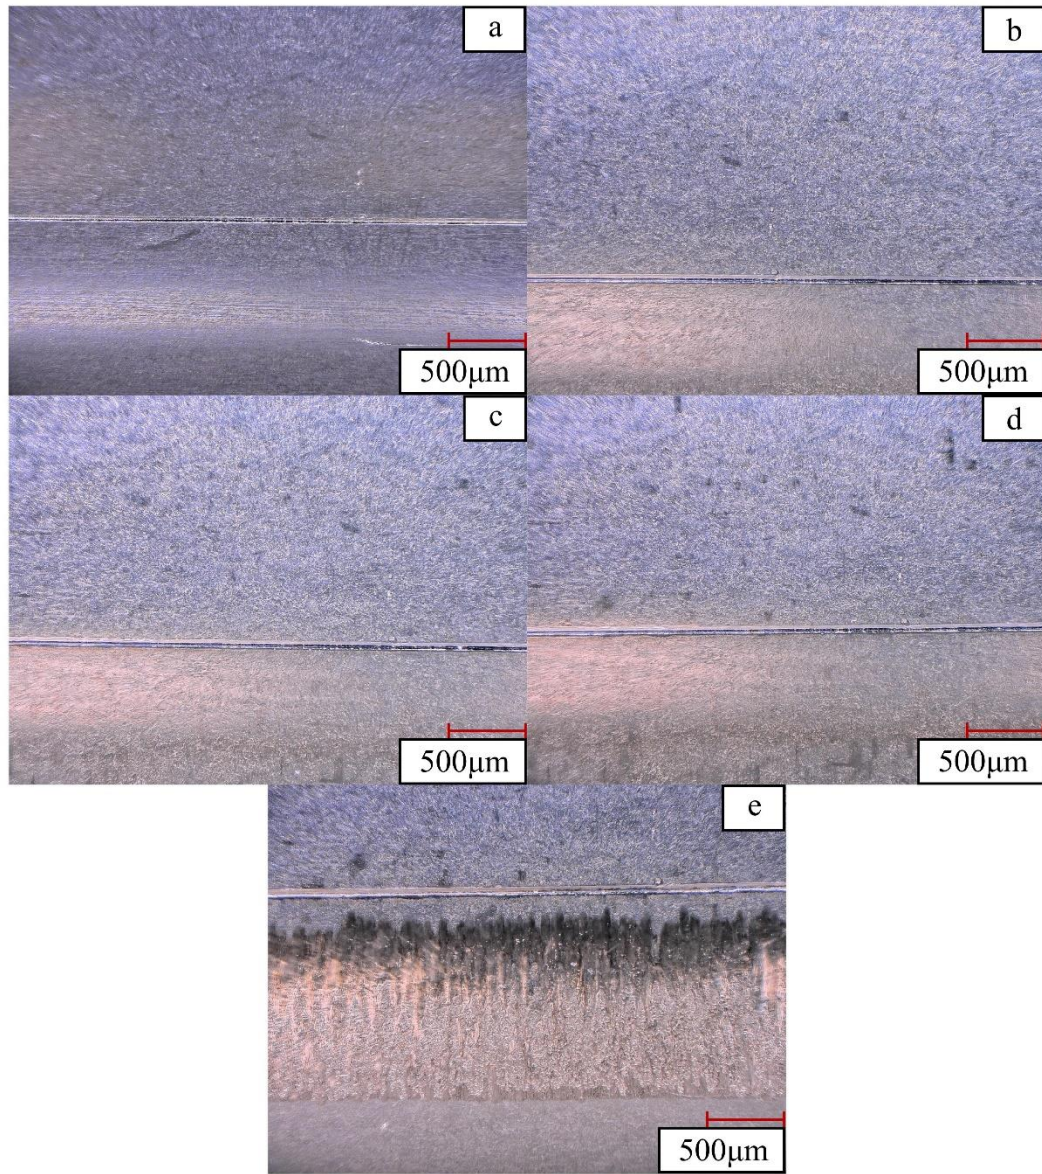
Figure 3.6: 100X microscopic of the LPSTC scratch in site 4 (a) before the test, and after the stages of (b) run-in, (c) A1, (dc) A2, and (e) A3.

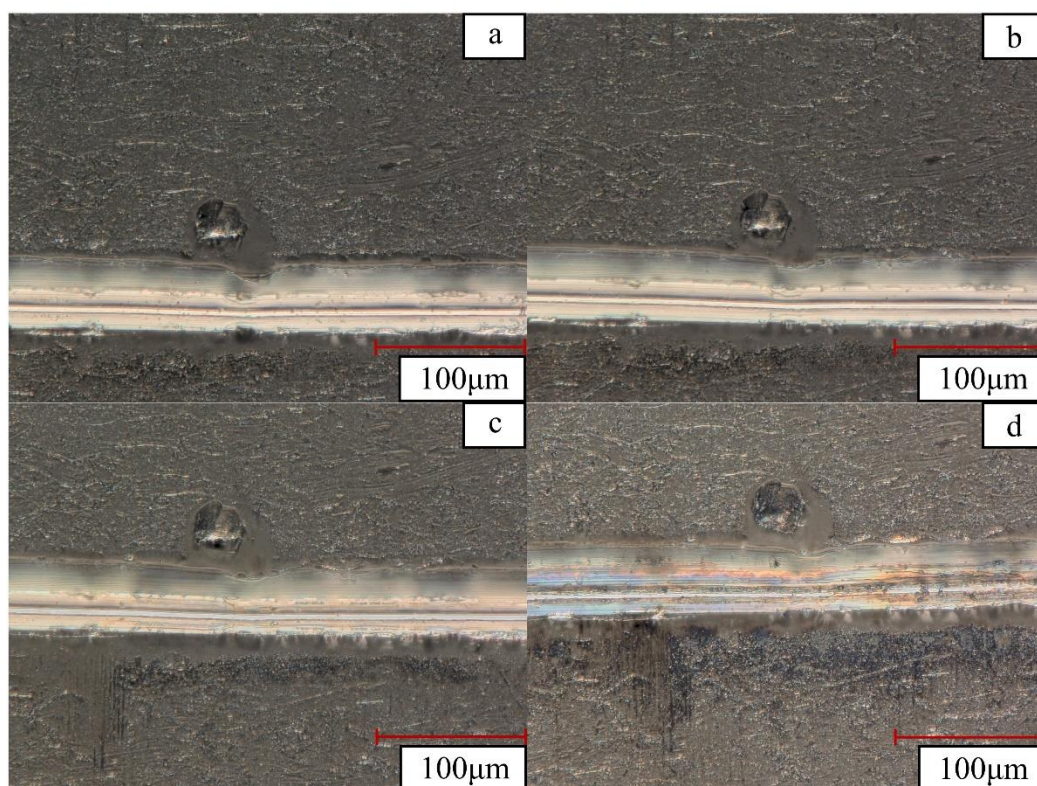
The magnified (1000X) images of the scratch at the same section are presented in Figure 3.7 after run-in and the three scuffing stages. As the gear pair was run, the shoulders developed smooth regions on both sides of the scratch, free from the surface features present on the rest of the tooth surface. The size of the zone increased in the profile direction as the gear pair was run-in, and then remained relatively steady in size until failure. The smoothened region on the lower shoulder was observed to be somewhat wider than that of the upper shoulder. Figure 3.7(b) shows some discoloration below the scratch shoulder in the direction of sliding that developed after run-in. It continued to develop further until scuffing failure in stage A3 (Figure 3.7(e)). This discoloration is a likely indication of bluing of the gear steel due to heat buildup combined with formation of a tribofilm (gold-brown discoloration) due to lubricant additives.

Figure 3.7: 1000X images of the LPSTC scratch in site 4 after (a) run-in, (b) stage A1, (c) stage A2, and (d) stage A3.

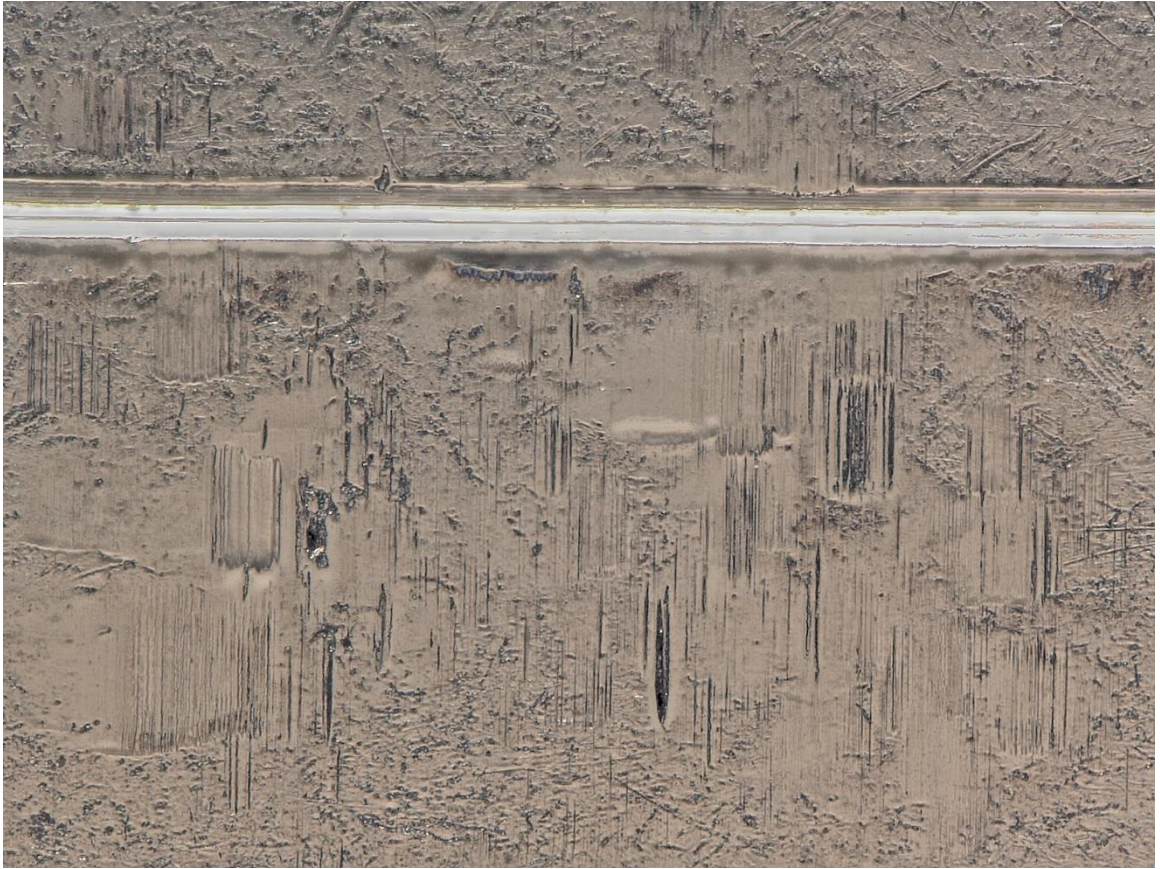
A small damage zone was observed after stage A2, as shown in Figure 3.8. It featured both finite-length micro-scratches and smooth regions extending below the

Figure 3.8: A damage zone near the LPSTC scratch (400X magnification).

induced scratch. It is possible that these micro-scratches were caused by small debris particles being removed from the shoulders, finding their way to the oil supply, and passing through the contact zone.

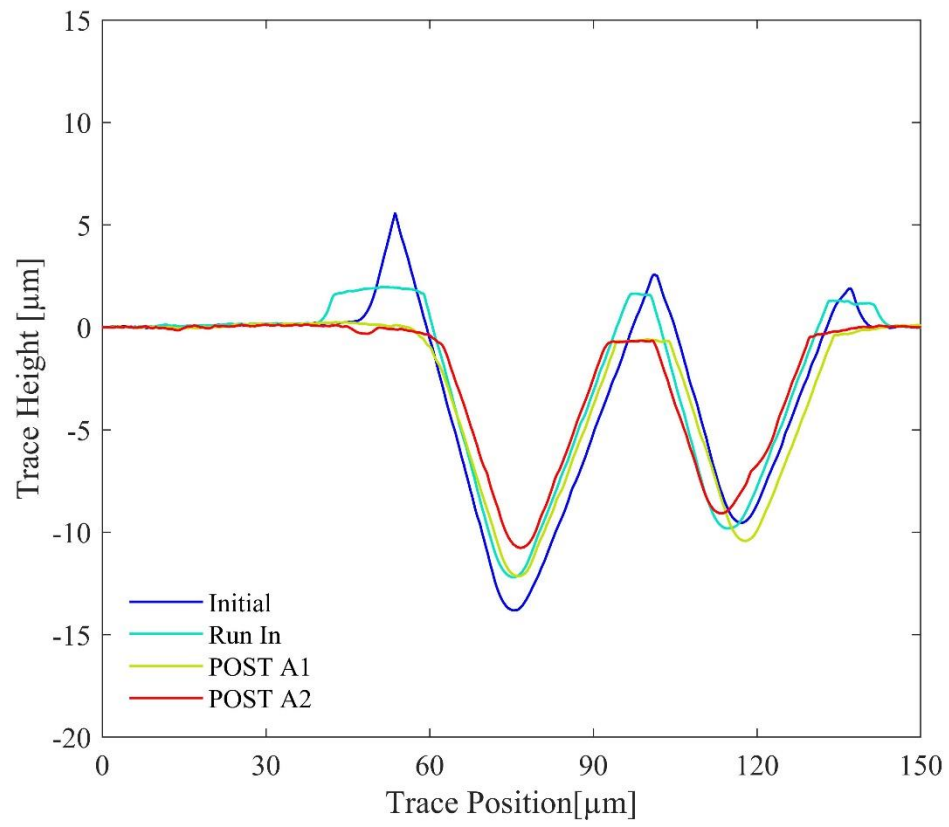
Figure 3.9 Roughness profiles of the diagonal scratch at site 7.

scuffing in the addendum of the pinion while it did not exist in Figure 3.10(d) after stage A2. Yet, Figure 3.10(d) has conclusive evidence that the first scuffing mark was initiated at the diagonal scratch at site 2 going towards the tip. Figure 3.11 show a close-up image of this early scuffing site originating from the scratch. The shoulders of these scratches with plus material are seen to be flattened at site 7 after stage A1 as shown in Figure 3.9.

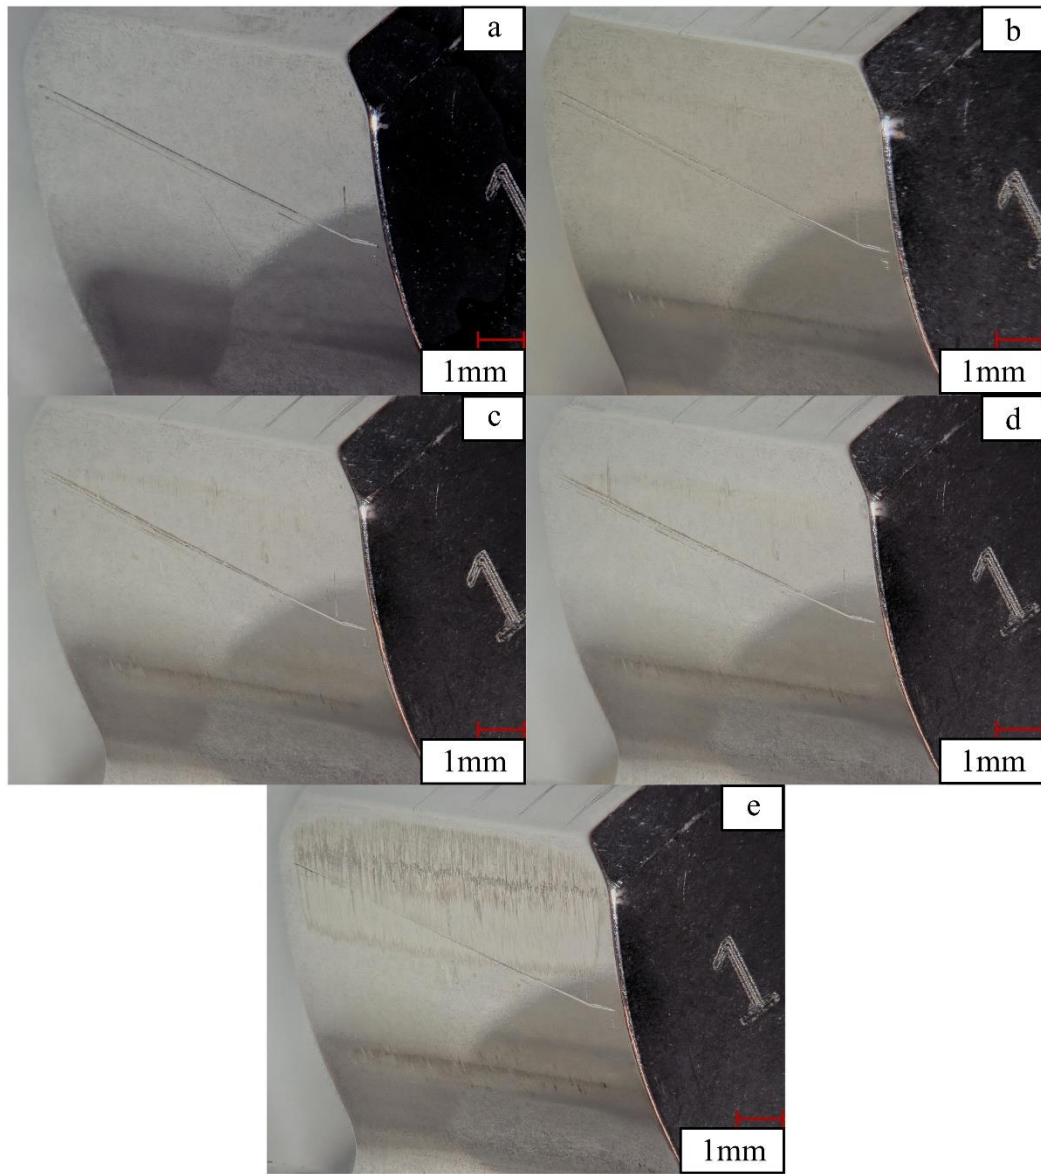
This gear pair also failed during scuffing stage A3 as listed in Table 3.1. Figure 3.10 shows images of the scratched tooth in its pre-test form as well as after run-in and scuffing stages A1, A2 and A3. It is clear from Figure 3.10(e) that there is a band of

Figure 3.10: Macro-images of the pinion tooth having a diagonal scratch in site 4 (a) before the test, and after the stages of (b) run-in, (c) A1, (d) A2, and (e) A3.

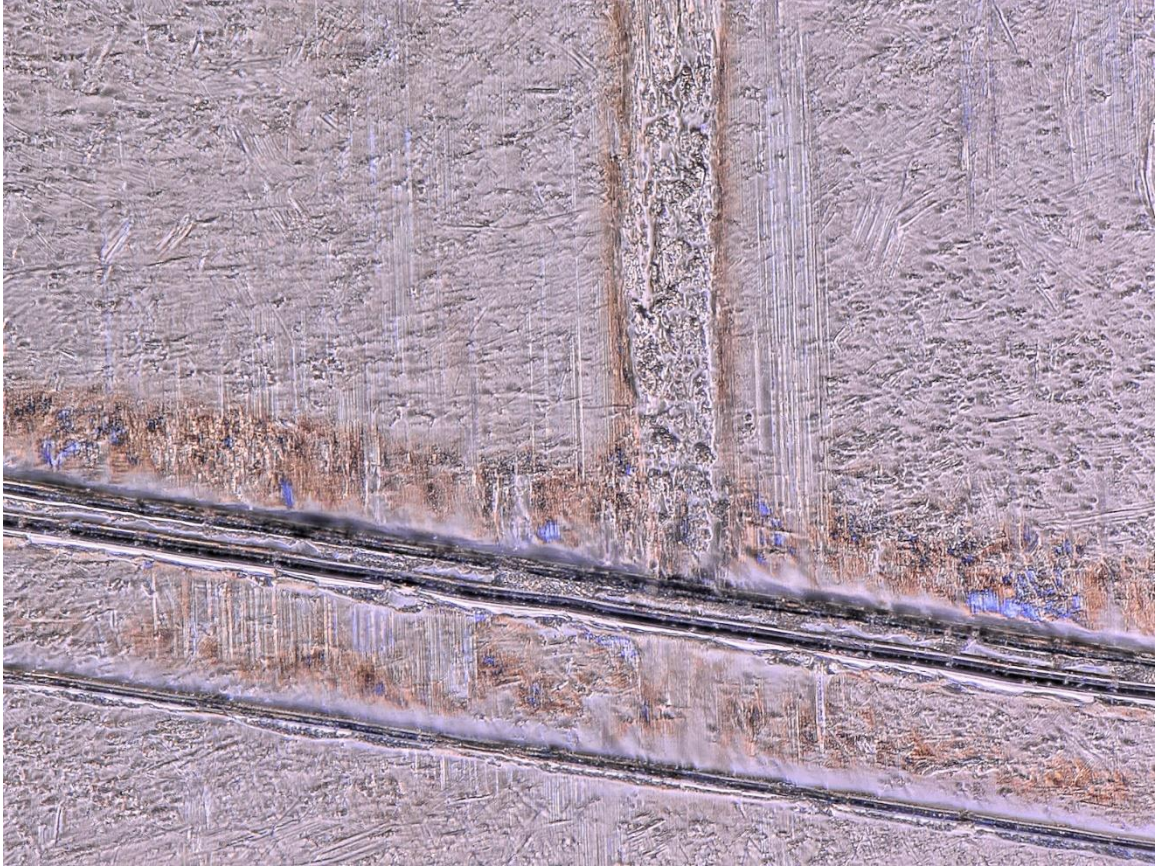
Figure 3.11: Scuffing initiation site along the diagonal scratch in site 2 after stage A2 (300X magnification).

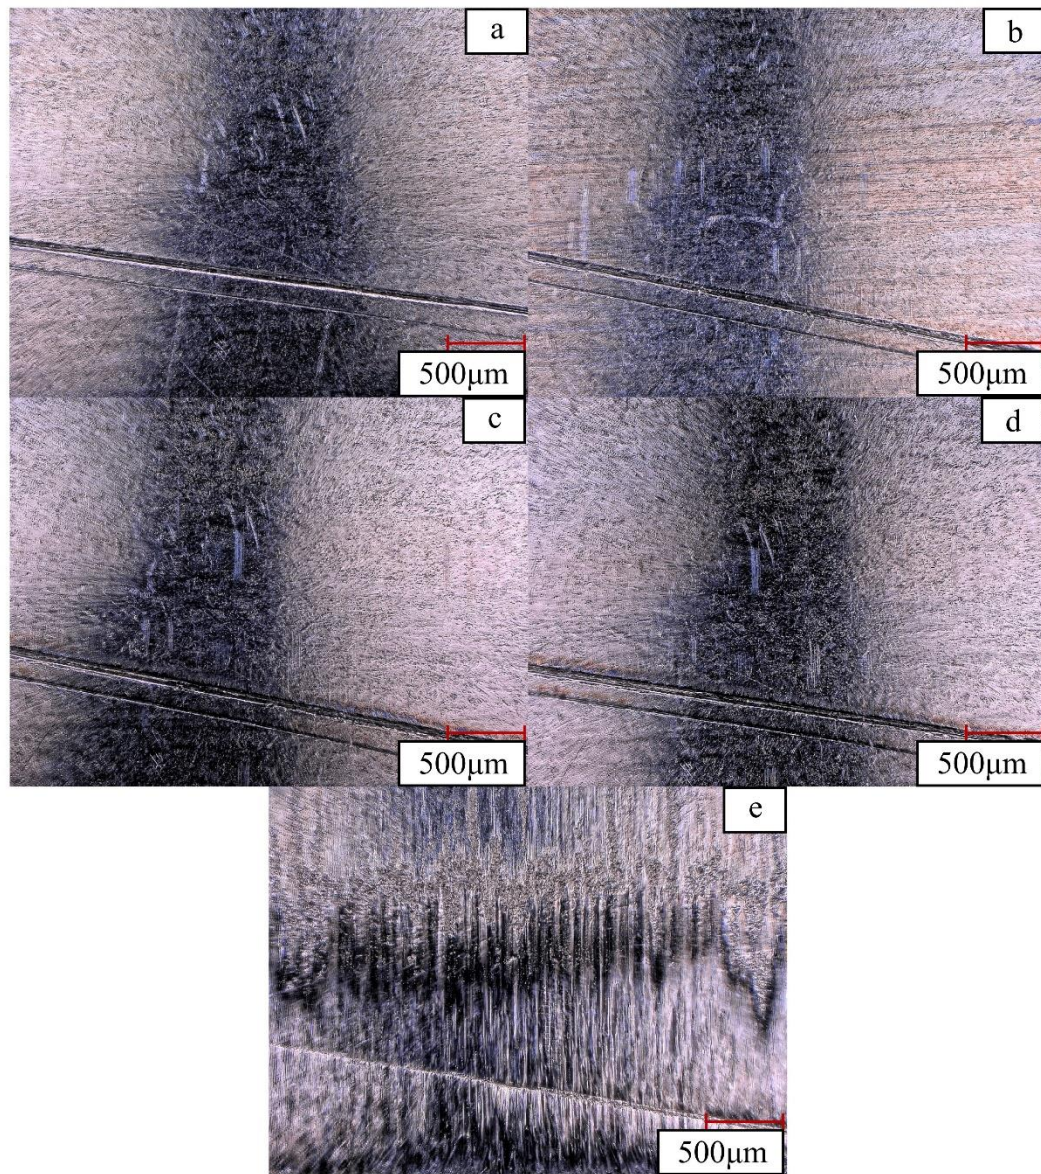
Figures 3.12 and 3.13 present magnified images of the diagonal scratch in section 4 after various stages of the test. It is seen in these images that the shoulder at the higher roll angle is smeared upwards while the leading shoulder in the bottom is either plastically deformed towards the center of the scratch or broken off in segments. Figures 3.12(e) and 3.13(e) also show the severity of the scuffing and its interaction with the scratch.

Figure 3.12: 100X microscopic images of the diagonal scratch in site 4 (a) before the test, and after the stages of (b) run-in, (c) A1, (d) A2, and (e) A3.

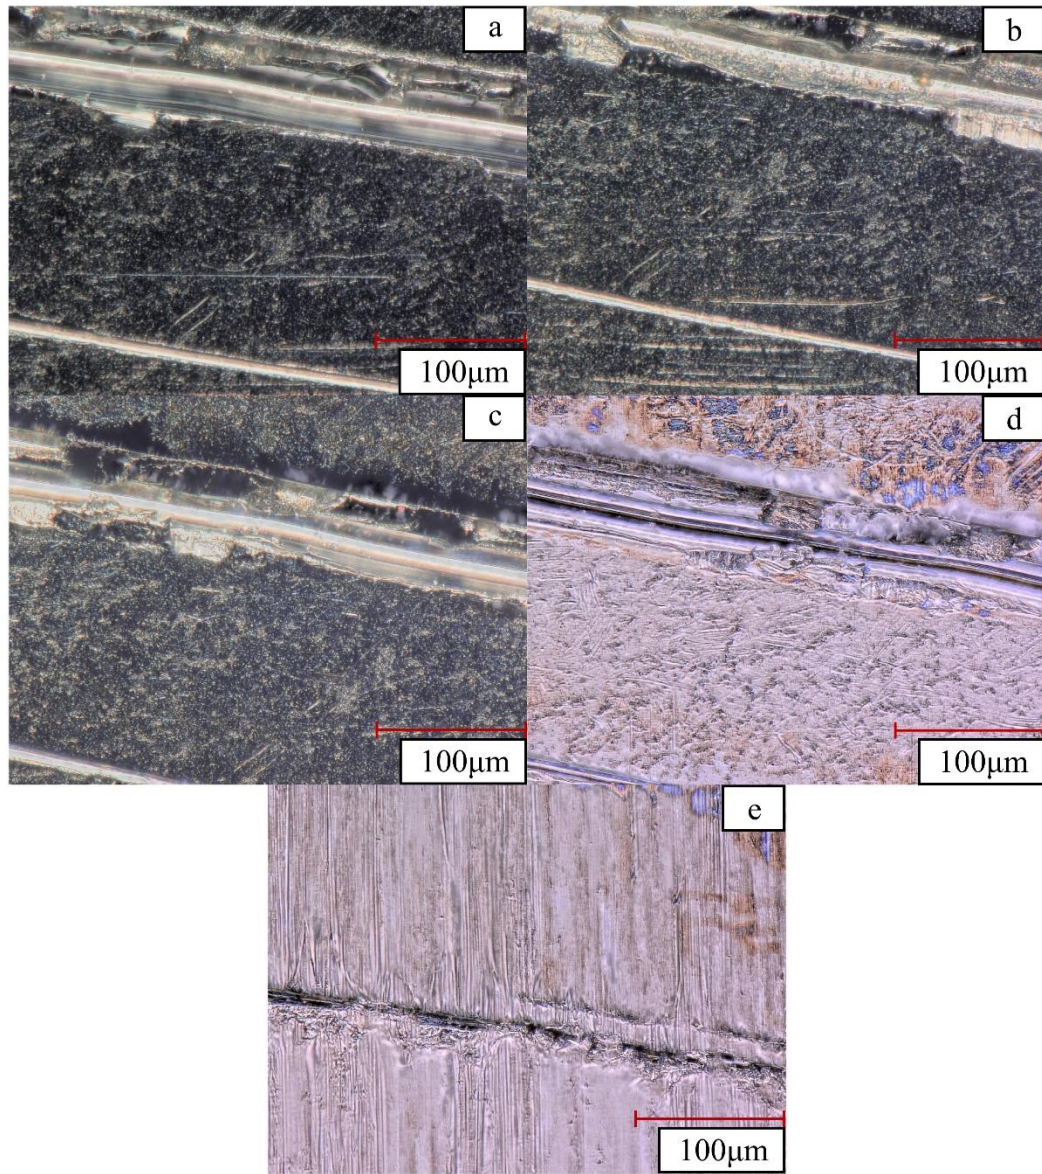
Discoloration was also present on and around the shoulders of the scratch. It began after run-in stage two and progressed until scuffing failure during stage A3. The extent of the discoloration was revealed in Figure 3.13(d) after stage A2 when the incidence angle of the microscope was changed to contrast this discoloration better. The bluing appears to be more extensive than the LPSTC scratch. The bluing was also more severe at the axial center of the tooth where contact pressure is highest.

Figure 3.13: 1000X microscopic images of the diagonal scratch in site 4 (a) before the test, and after the stages of (b) run-in, (c) A1, (dc) A2, and (e) A3.

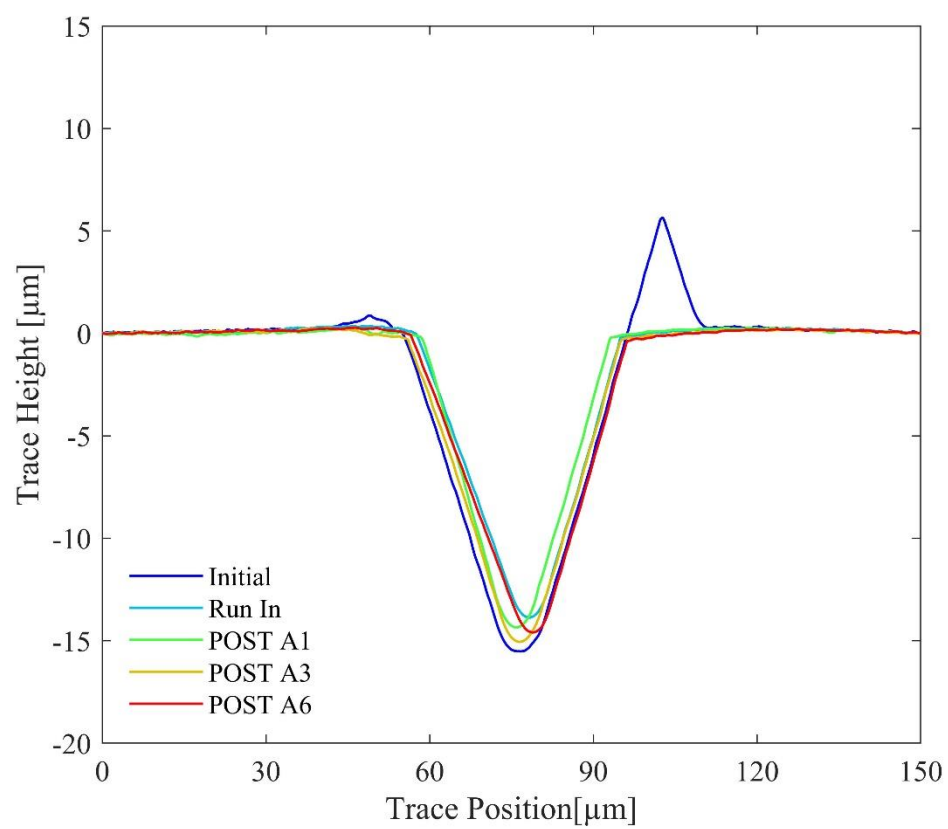
The final damage-induced gear pair to be tested had a pinion with axial scratch damage along its HPSTC line. Figure 3.14 shows roughness traces across this scratch at section 4 in its pre-test form as well as after run-in and staged tests. Focusing on the pre-

Figure 3.14: Roughness profiles of the HPSTC scratch at site 4.

test scratch profile (blue line), the dimensional parameters of this scratch where $H = 21 \mu\text{m}$, $\alpha = 0.27$, $\beta = 2.55$, and $\gamma = 0.48$. This gear pair was run through four run-in stages before the staged scuffing test. The plus material on the scratch shoulder is seen to wear off completely after the run-in stage. This test was then run through the staged scuffing test and failed during stage A9, as listed in Table 3.1. The pinion tooth with the scratch is shown in Figure 3.15, including pre-test, after run-in, and stages A1, A2, A3 and A9. In Figure 3.15(e) after stage A9, the pinion tooth is shown to exhibit severe addendum and dedendum scuffing. In addition, severe discoloration along the HPSTC scratch is also evident after earlier stages. 100X and 1000X images of the scratch zone at the same test stages are shown in Figure 3.16 and 3.17, respectively. The bluing again occurs after the scratch in the direction of sliding and is most severe at the facewidth center of the tooth. This suggests that the bluing is caused by increased contact pressure, potentially resulting in asperity interactions. This is complemented by Figure 3.17 where a wide flattened zone is observed above the scratch. Otherwise, no initiation sites or scuffing cells were observed. Despite an initiation site not being captured, there is sufficient evidence from the damage visible in Figures 3.16(d) and 3.17(d) to suggest that the reason for this failure was the HPSTC scratch.

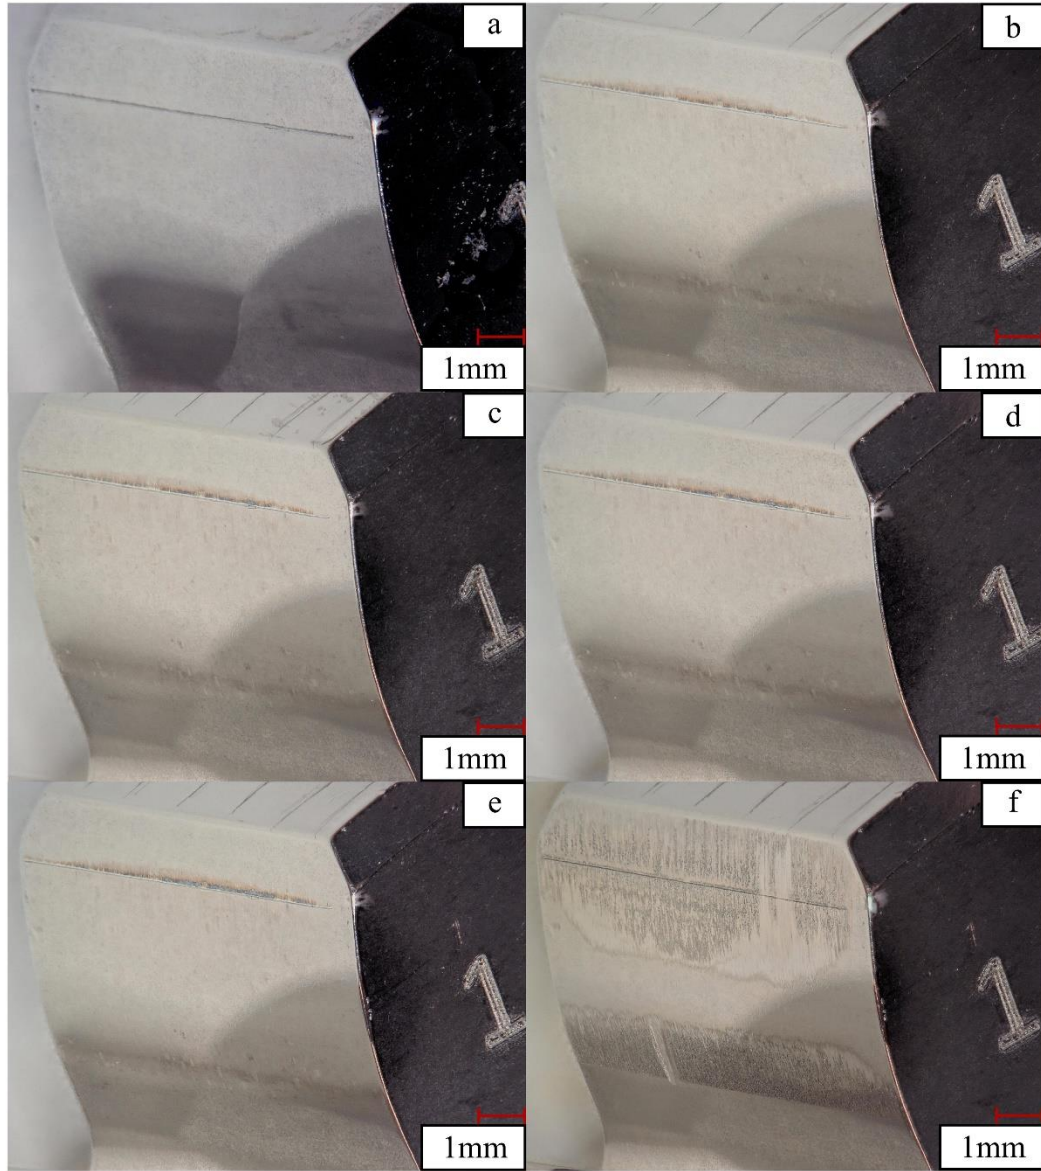
Figure 3.15: Macro-images of the pinion tooth having the HPSTC scratch in site 4 (a) before the test, and after the stages of (b) run-in, (c) A1, (d) A2, (e) A3, and (f) A9.

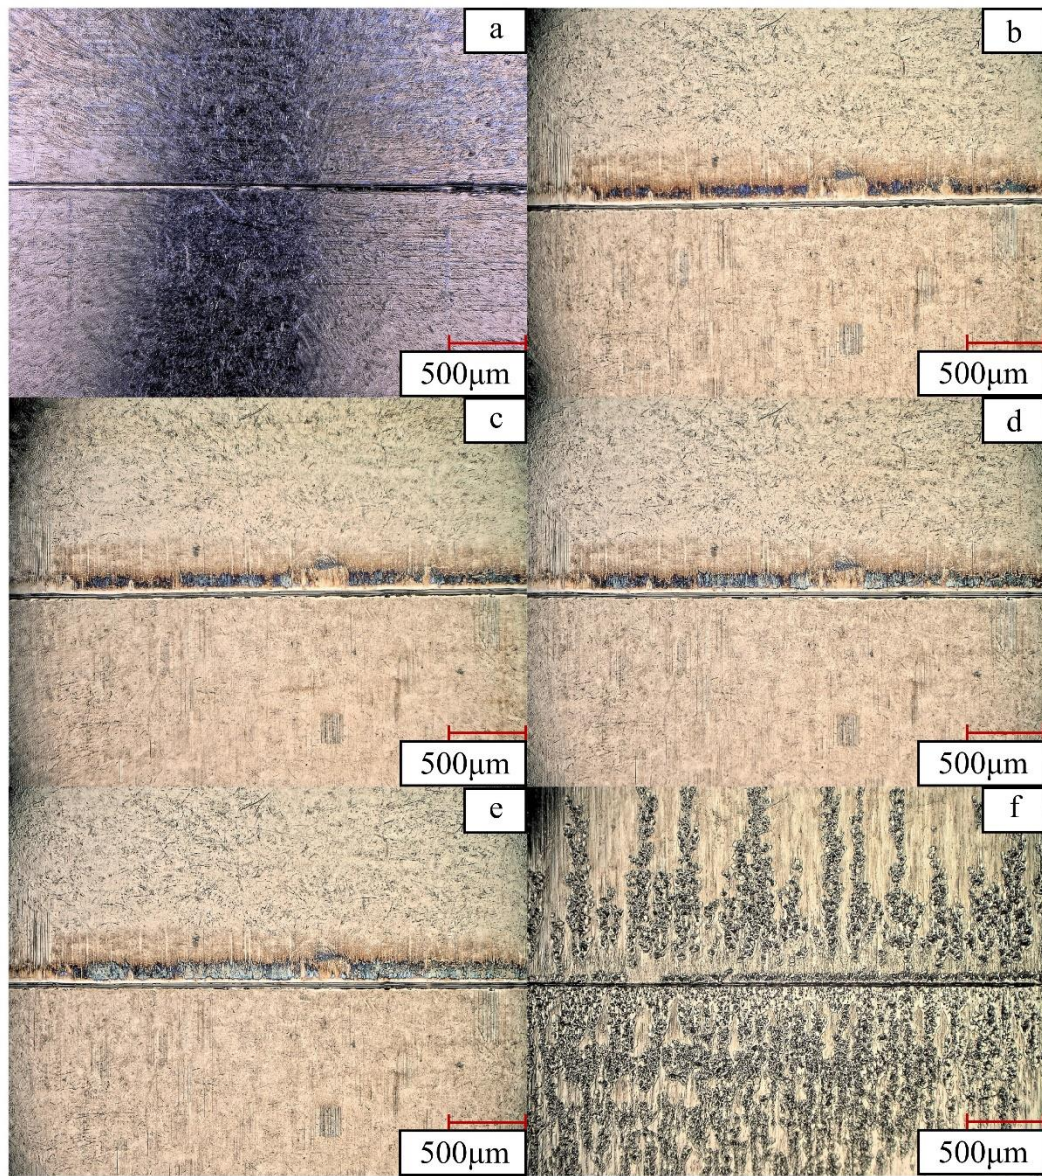
Figure 3.16: 100X microscopic of the HPSTC scratch in site 4 (a) before the test, and after the stages of (b) run-in, (c) A1, (d) A2, (e) A3, and (f) A9.
